## **DOCUMENTATION STAIRCASE RENOVATION 2014 - 2023**

**ARCHITECT SVEN MARKELIUS' COLLECTIVE HOUSE  
JOHN ERICSSONGATAN 6, STOCKHOLM**

**Fågelbärsträdet 13  
Stockholm municipality**

**2023-05-16**

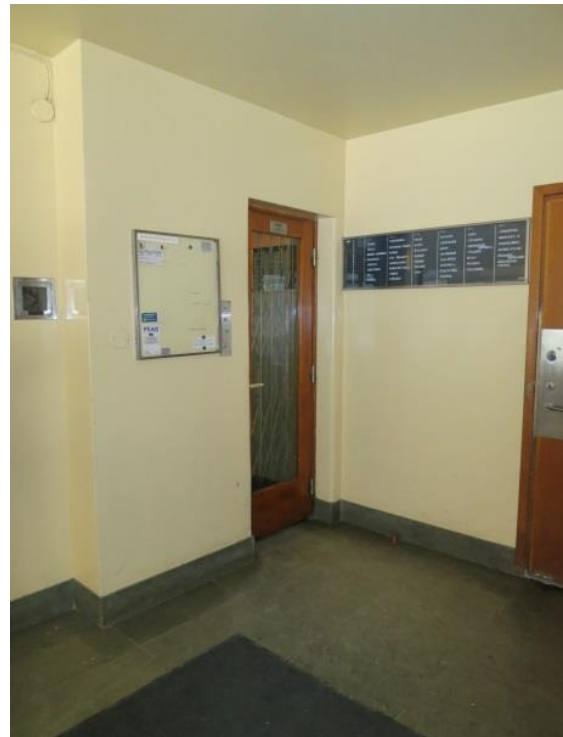
*The notice board needs to be aligned and adjusted in height like the nameplate, for example. The bulletin board is not original as the nameplate is.*

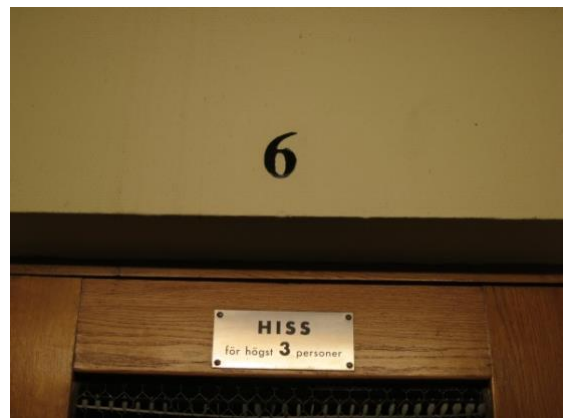
*Floor number from pasted-on plastic sticker.*

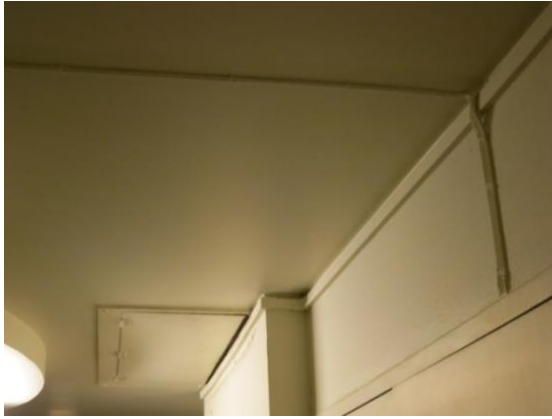
*Electrical cords for fixtures are unfortunately routed across the corridor. The eaves against the ceiling contain, among other things, data and telephone lines.*

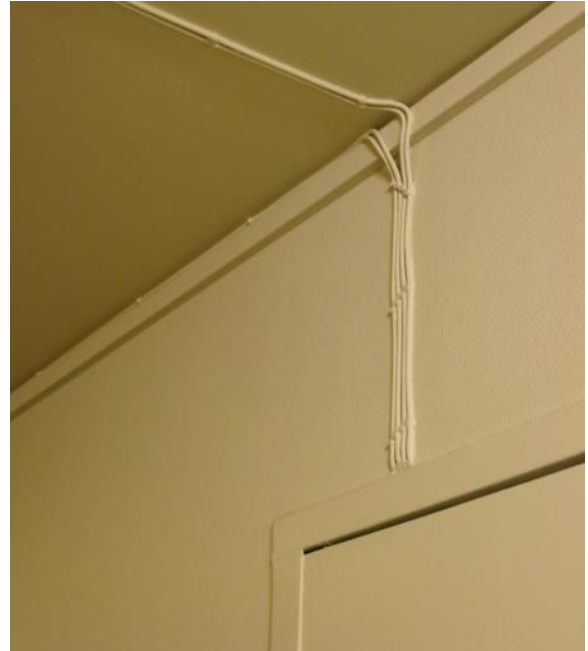
*Electrical lines are replaced on all levels, more or less great need. Carried out by electrical contractor.*

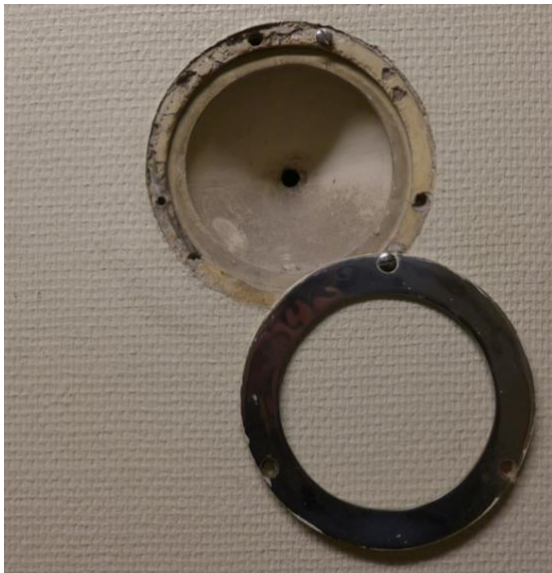
*Rough painted fabric on all walls. The round bolted detail next to all elevator doors, what is this?*

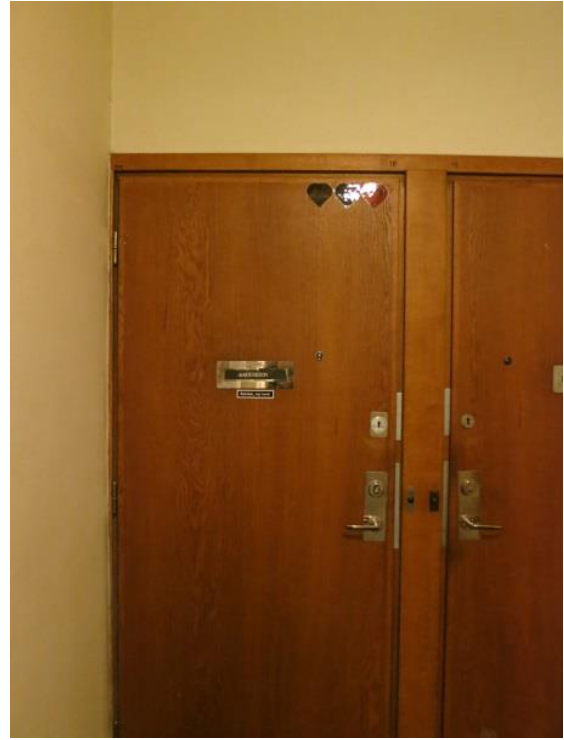
*Sticky notes should be banned in general.*

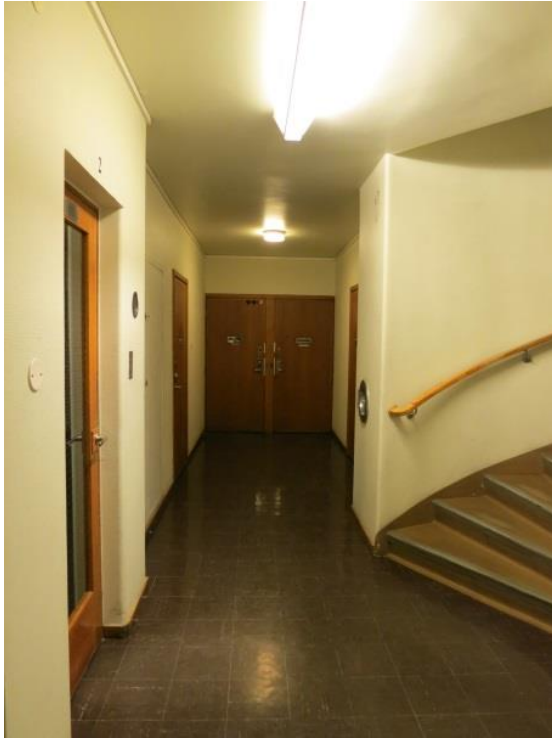
*Take a stand on existing fixtures. Mixed models round and oblong.*

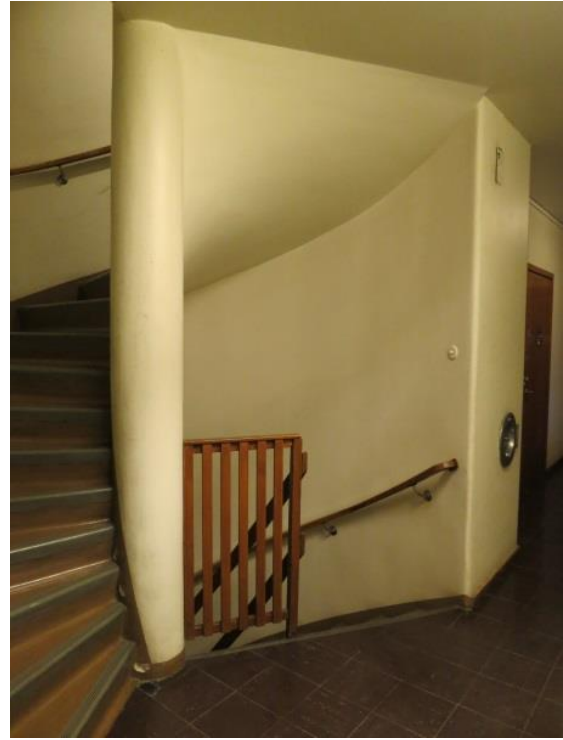
*Take a stand on the existing railing to the basement. Compare with the stair railing to the entrance floor, below.*

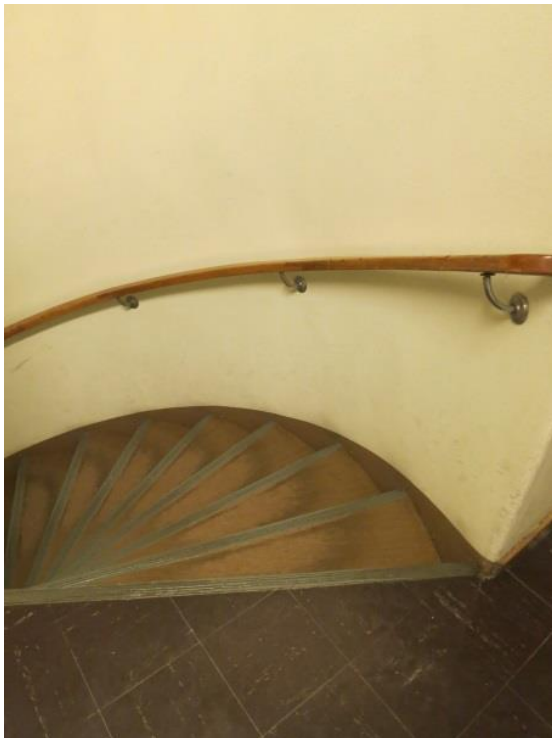
*Take a stand on the existing floor on the landing and on the stairs including stair nosings.*

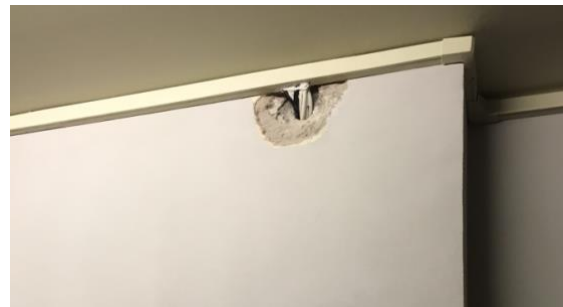
*Vertical electricity- and fiber cables run in the elevator shaft and the new electrical duct at the ceiling has been drilled out. Sometimes the wall broke a little. Due to the very hard concrete, new installations could not be built into the walls.*

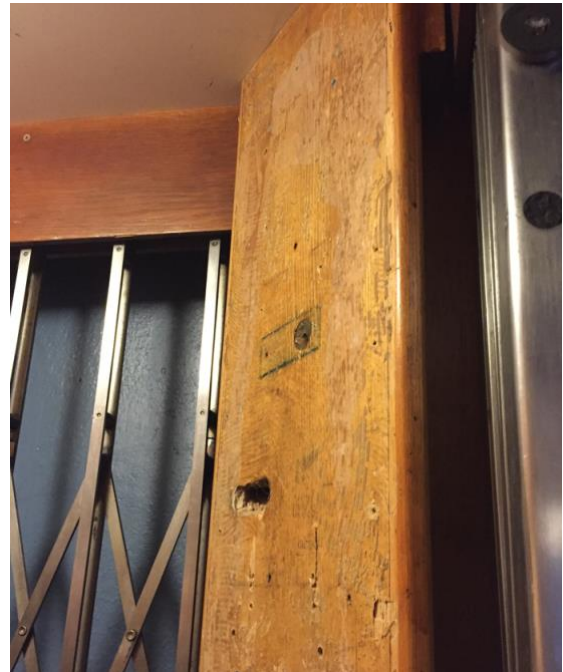
*The original design with rounded edges emerged during disassembly but was badly damaged.*

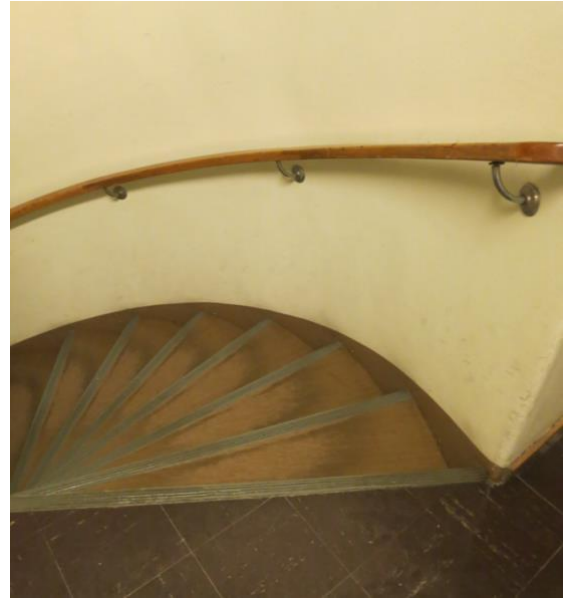
*Worn stairs with painted plinth against the wall, probably from the 1970s.*

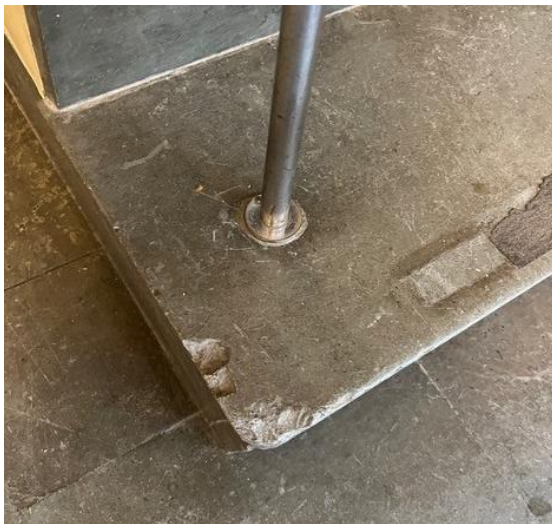
*Damage to the limestone in the exposed stair corner*

*The limestone stairs have been cleaned of non-slip tape and polish and small damages, e.g. on the exposed outer corner of the lower step, have been repaired with stone repair cement.*

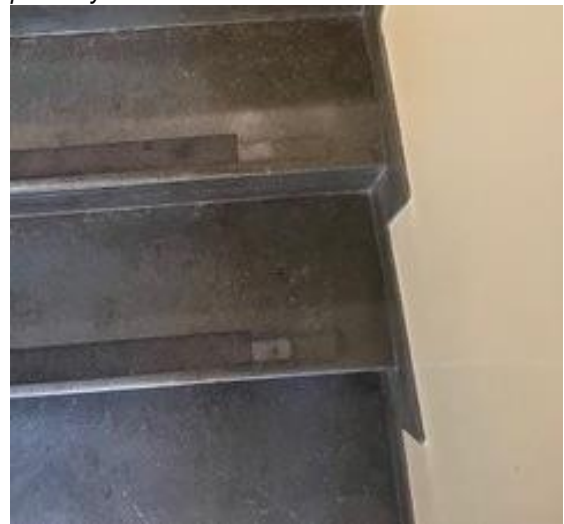
*Worn out slip tape and traces of old tape.*

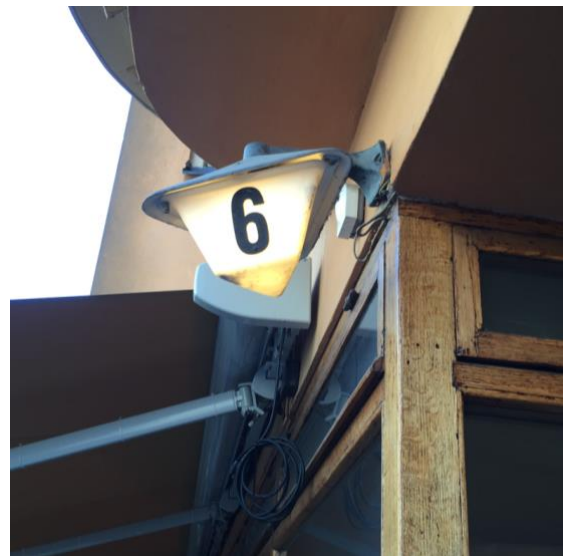
*The outdoor fixture replaced with a standard fixture from the 1960s-70s, a little tufted.*

*Newly manufactured street number luminaire based on a model from 1935, designed by AIX Arkitekter.*
