## **DOCUMENTATION STAIRCASE RENOVATION 2014 - 2023**

**ARCHITECT SVEN MARKELIUS' COLLECTIVE HOUSE  
JOHN ERICSSONGATAN 6, STOCKHOLM**

**Fågelbärsträdet 13  
Stockholm municipality**

**2023-05-16**

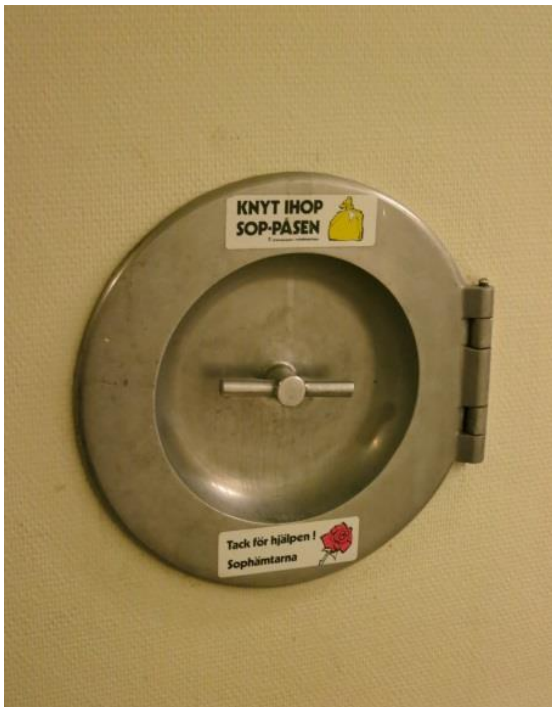
*Sticky notes should be banned in general.*

*New text about GARBAGE SHAFT and former LAUNDRY SHAFT is stenciled over the respective hatch.*

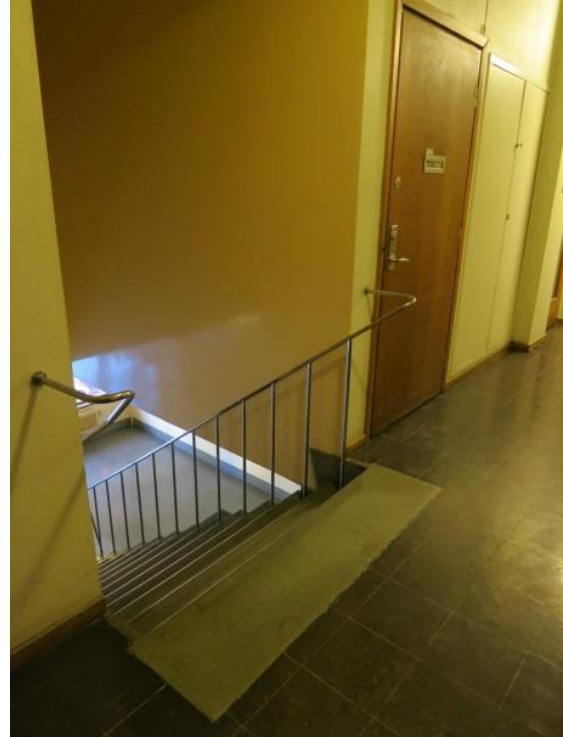
*Take a stand on the existing floor on the landing and on the stairs including stair nosings.*

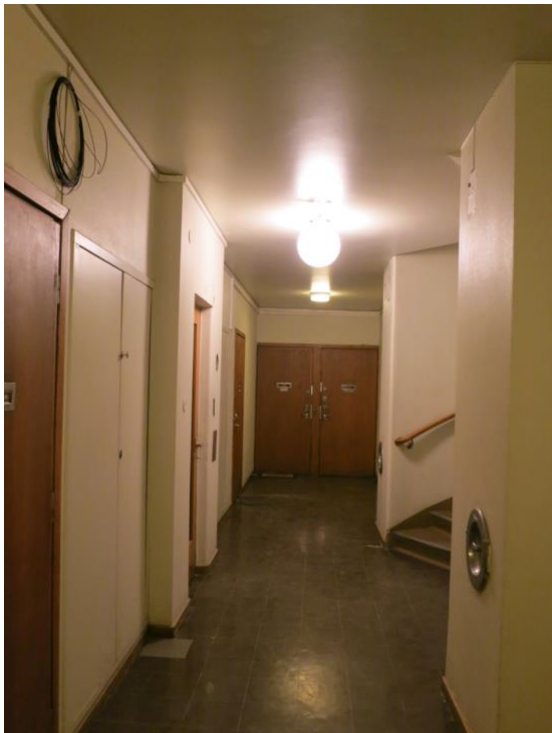
*Test luminaire, round globe is tested in front of the lift. Further away, a round, flat one from the 1970s still sits. New cable strip installed at the ceiling and the fiber runs have begun.*

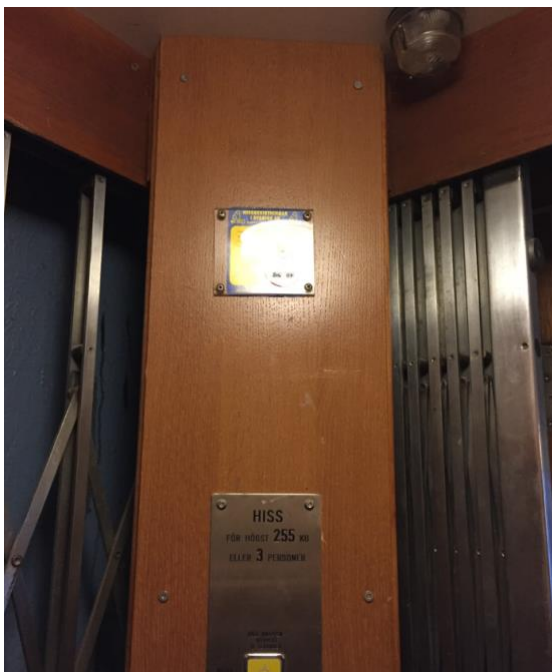
*A later added bulletin board in the elevator, removed.*

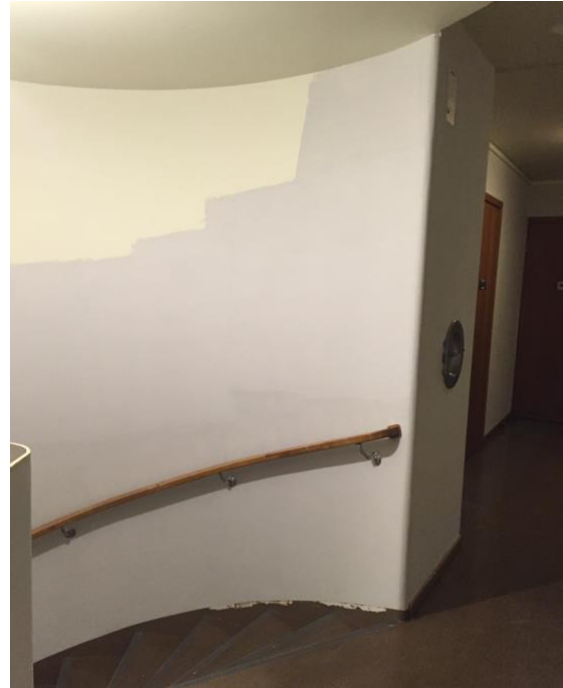
*The fabric of walls is spackled to a smooth surface*

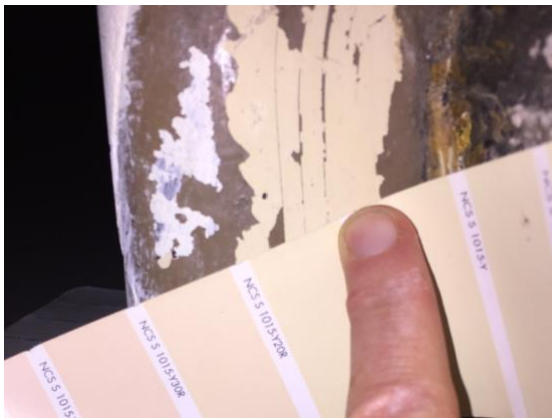
*First test painting.*

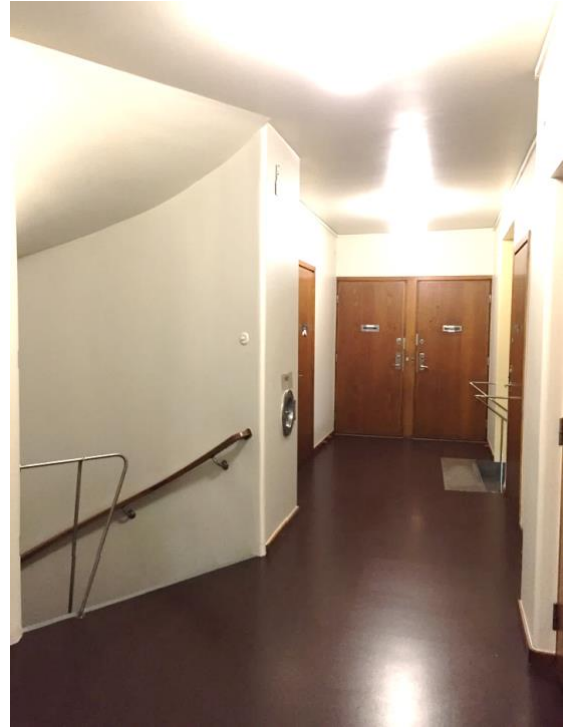
*The entrance doors have been surface-renovated by cleaning and oiling/waxing. All fittings have been retained, signage is kept uniform according to brf's rules.*

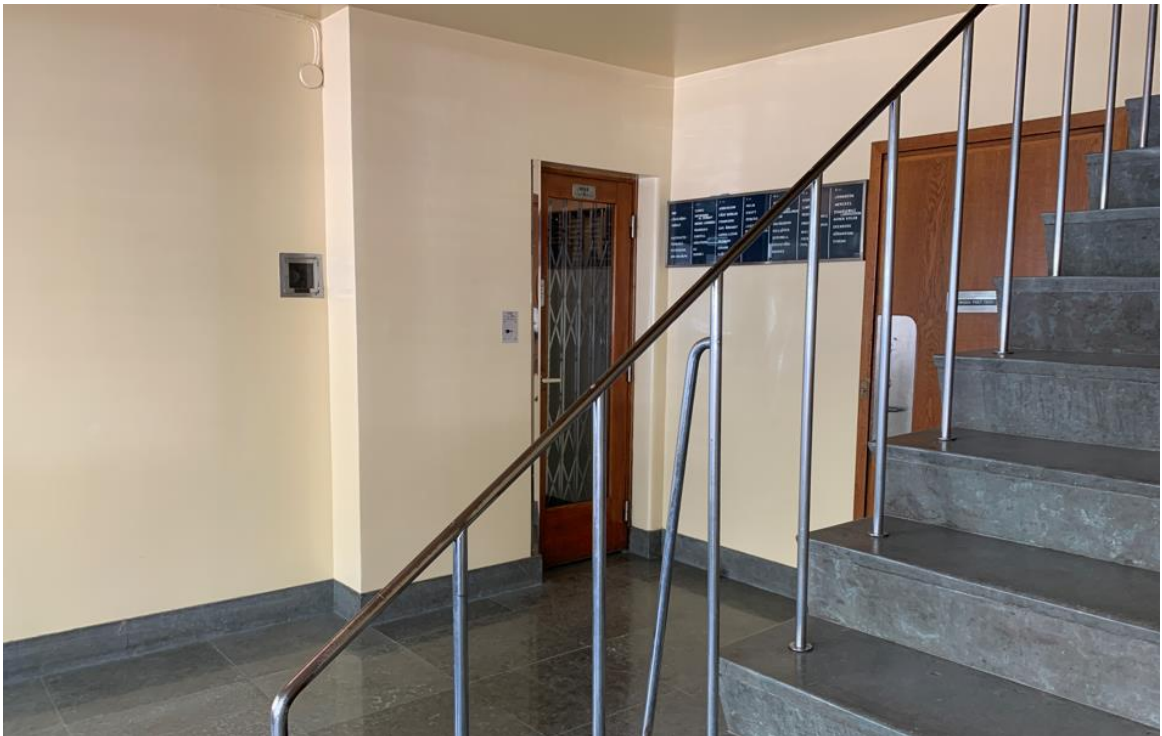
*In the entrance vestibule, the later added notice board to the left of the elevator door was removed and the original name board is preserved.*

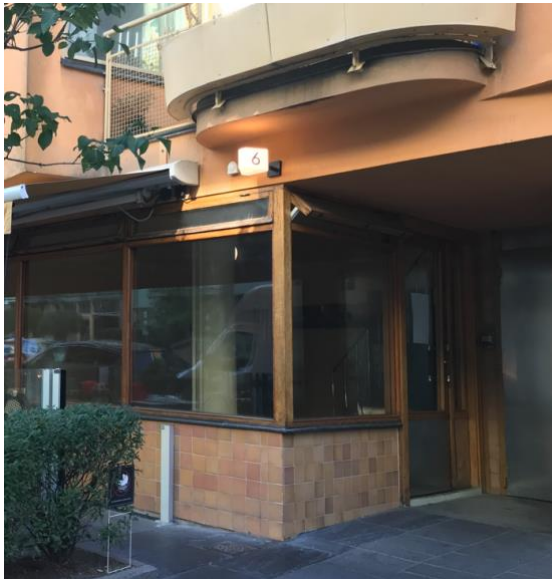
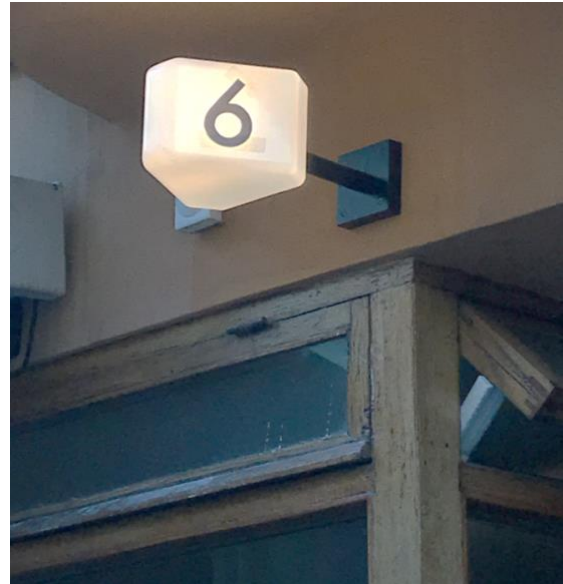
*Newly manufactured street number luminaire based on a model from 1935, designed by AIX Arkitekter.*
